# Mt Mansfield Communication Site Repairs

The maintenance and service of communication sites is a key job of RTS technicians. In June of 2018, RTS supervised and performed repairs to the tower located on Mt. Mansfield. Foundational pipes used to support the structure were bent when tons of ice were shedded from the structure in November, 2016. While temporary repairs were made immediately and the repairs had functioned well, the damaged components ultimately needed to be replaced.

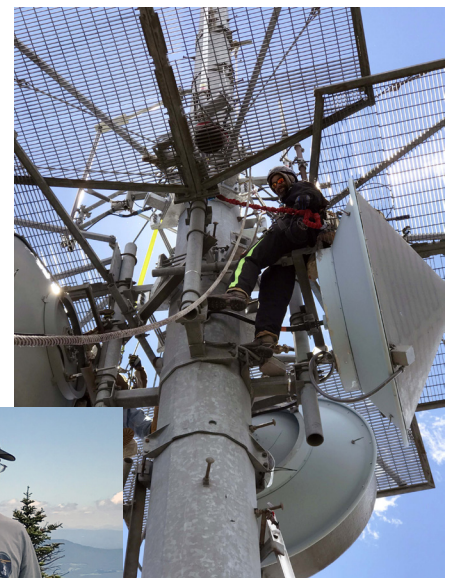
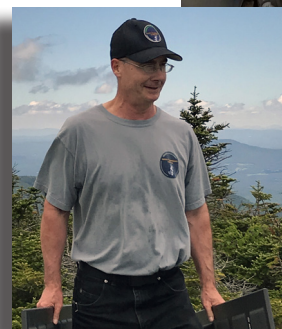
Everything must be carried in and out of the site by hand. To safely complete maintenance work such as this tower repair, a team of people is engaged on the project.

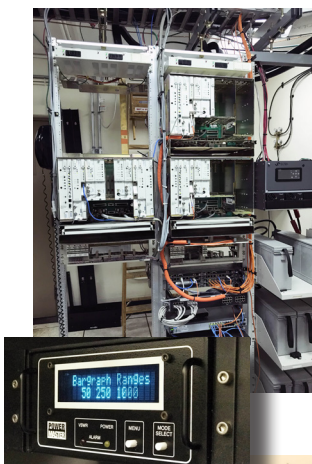
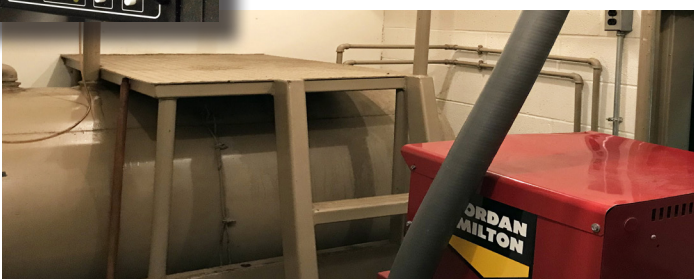
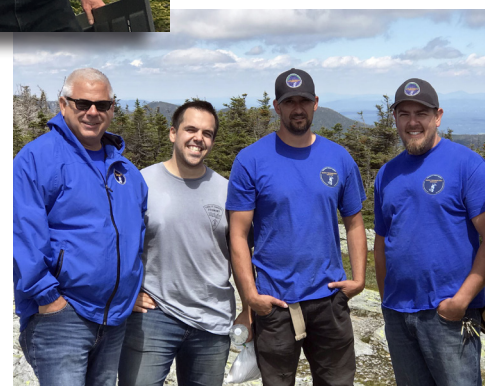
At the site, a maintenance shed houses radio and electronic support equipment. The 275 gallon fuel tank and generator ensure the equipment will be able to operate in severe weather and power outages.
